# Assessment of “The Serious Learner” Outdoor Concrete Statue in TTU, Ghana: A Restoration Process (Before and After)

This paper assesses the restoration process (before and after) of "The Serious Learner", an outdoor concrete statue found at the forecourt of Oduro block, Takoradi Technical University (TTU)-Ghana. Direct observations and unstructured interviews under the qualitative research method were employed to elicit data from respondents such as art lecturers and students of the Sculpture Department, TTU. Data were analyzed using archival studies, descriptive and visual analysis tools with a studio-based process. The study revealed that "The Serious Learner" outdoor concrete statue formed an integral element of landscaping at the Oduro block, TTU. However, significant features such as the pedestal, body parts, lighting system and finishes of the outdoor statue have deteriorated due to weathering and had received no restoration since its erection. Repairs and management of artefacts in public space, not only in TTU, should be performed every two years to ensure their longevity and posterity as conservation and restoration method is significant in outdoor sculptures.

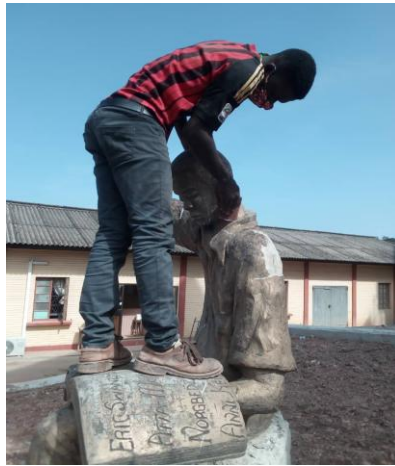
**Fig. 1. Surface preparation of the outdoor concrete statue**

It was revealed that in undertaking the surface preparation of the outdoor concrete statue, the artists provided appropriate care to the substrate for repairs. The artists cut the border of the broken-off area. The surface preparation began by removing broken concrete surfaces with a hammer, plier and wire brush. The artists then remove the cracks on the surface to provide a better bonding and solidifying with the existing concrete. Paint peel-off was removed by scraper and coarse sandpaper to establish the degree of the repair. The artists remove all powder substances and dirt from the statue. Again, concrete deterioration such as cracking and delamination of metal caused by corrosion were removed for proper repairs and management. The artists finished the surface preparation to replicate the original appearance of the statue. A

maintenance strategy is the most effective way to help shield the outdoor concrete statue of "The Serious Learner" from deteriorating. Fig. 1 shows a surface preparation on the sculpture (The Serious Learner).

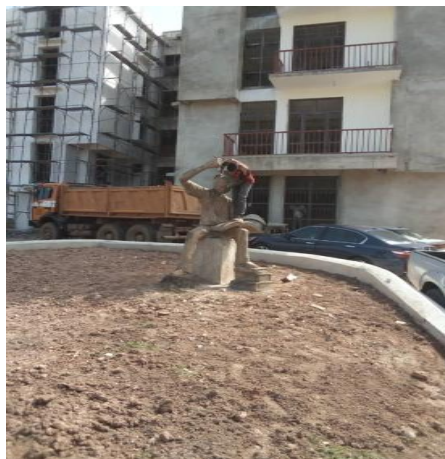
**Fig. 2. Finishing with cement mixture and clearing of surroundings**

The study revealed that the detailing work with sealants required considerable attention. However, artists filled active cracks with cement mixture as penetrating sealants. A protection system such as the resin application was applied to the statue to protect it and increase the length of the service life of the outdoor concrete statue. The artists prepared land around the statue with cutlass and hoe to make it bear for replanting green glass [31], as shown in Fig. 2.

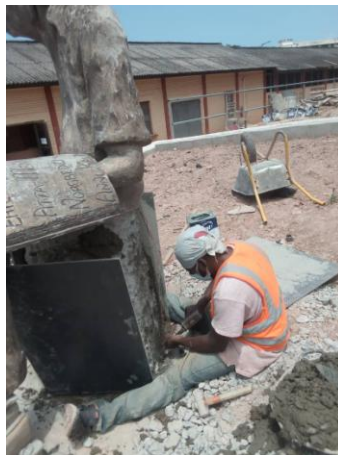
**Fig. 3. The artist lays tiles around the pedestal**

The surface of the pedestal was properly prepared, suitably levelled, cleansed, dried, and free of dust, grease or any loose material. The pedestal surface was secured without deflection and capable of carrying any additional load. In tiling the walls of the pedestal, consideration was given to floor tiles because of their heavyweight compared to wall tiles. Its weight of 3kg per m<sup>2</sup> allowed the artists to use it together with adhesive and grout. The artists performed different roles in concentrating on laying and bedding the tiles, while the others provided a constant supply of loose tiles and made cuts and retrieved tools as needed. A rubber mallet was used to gently but firmly tap and beds each tile into the mastic. Artists took appropriate care not to press or shift the tiles around to avoid having the mastic squeeze up into the grout lines between the tiles. Plastic spacers were placed

between each tile as necessary. The mastic did not stick to the spacers, which were easily removed before the grouting of the joints began. The artists used a 4-foot level to ensure that tile edges were aligned and levelled across their surface.

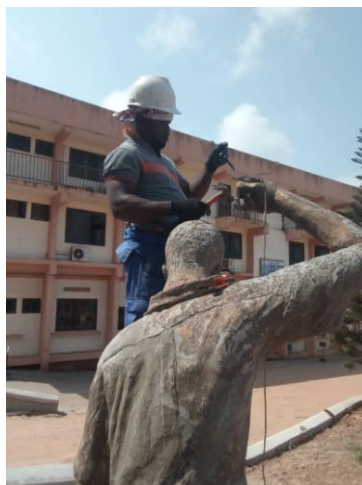
**Fig. 4. Passing of electric wire and fixing of the bulb**

The artists used electric cable encased in a half ½ inch PVC pipe through "The Serious Learner" concrete statue from the pedestal and to the right hand of the figure holding the lamp. The artists prepared the ground by creating a pipe-laying channel from the statue to the source of tapping electric power at the Oduro block. The bulb was fixed to the right hand of the sculpture (The Serious Learner) to complete the lighting process. Fig. 4 shows the process of passing electric wire and the fixing bulb to the statue.

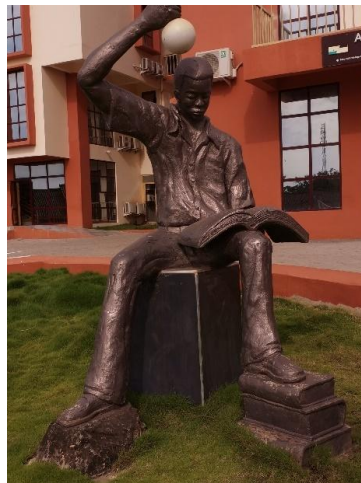
**Fig. 5. Application of enamel paint**

Before applying paint to the statue, the artists ensured that the statue was free of all forms of dirt by washing it with a soap solution and a duster. It was then allowed to dry for thirty minutes to ensure the paint sticks well to the body of the sculpture. The paint was then applied with a brush onto the statue with a half-gallon of enamel paint mixed with two litres of thinner. The finishing was done to retain the original form of the statue with bronze enamel paint, as shown in Fig. 5.

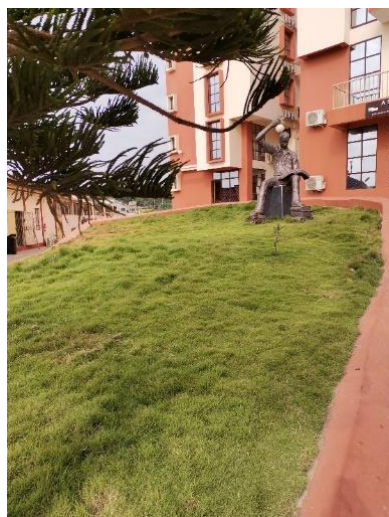
**Fig. 6. Greening the sculpture's environment**

After the preparation of the land, two tipper truck trips of black soil were spread onto the prepared land by the artists with rakes. The ten (10) bags of green grasses were planted in the black soil on the prepared land with cutlasses and watered twice a-day (morning and evening). It was done continuously for one month with watering cans. This process was to ensure proper germination of the green grass [31]. Fig. 6 shows the greening of the sculpture's environment.

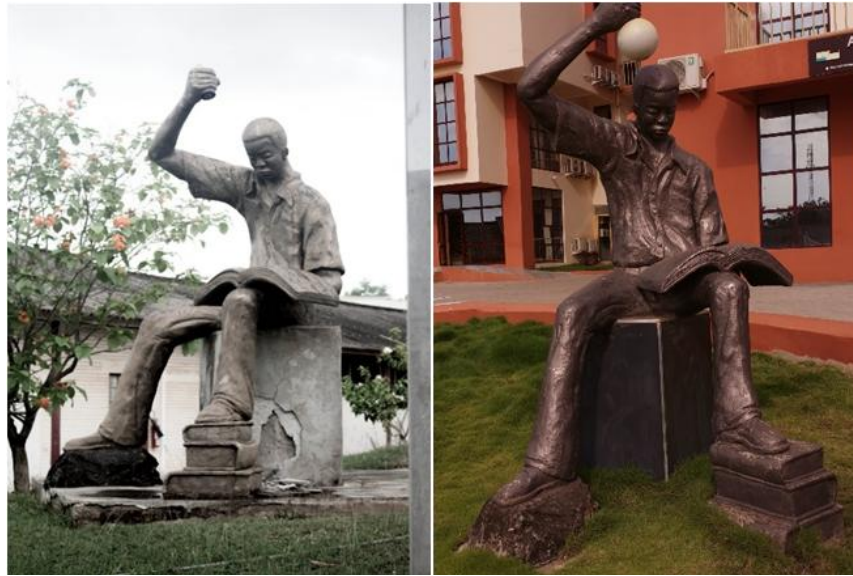
**Fig. 7. Before and After Restoration**

**Information on the State of Conservation/Structural conditions:** Surface molds, mildews, fungi, cracks, crazing, discoloration, scaling and curling of slow wear and damages, paint peel-offs, breakages at joints.

Surface appearance: Break in joints and surface discoloration.
